<u>MODEL</u>	LC26P55E	LC32P55E	LC37P55E	LC26P70E
	LC32P70E	LC37P70E	LC32GA8E	LC37GA8E
	LC32GD8E	LC37GD8E	LC32BT8E	LC32GA9E
	LC37GA9E	LC32GD9E	LC37GD9E	LC26SA1E
	LC32SA1E	LC37SA1E	LC32SD1E	LC37SD1E
	LC37AD5E

SYMPTOM Set is dead and IC708 in the PSU section is defective

Reference – SP080601X

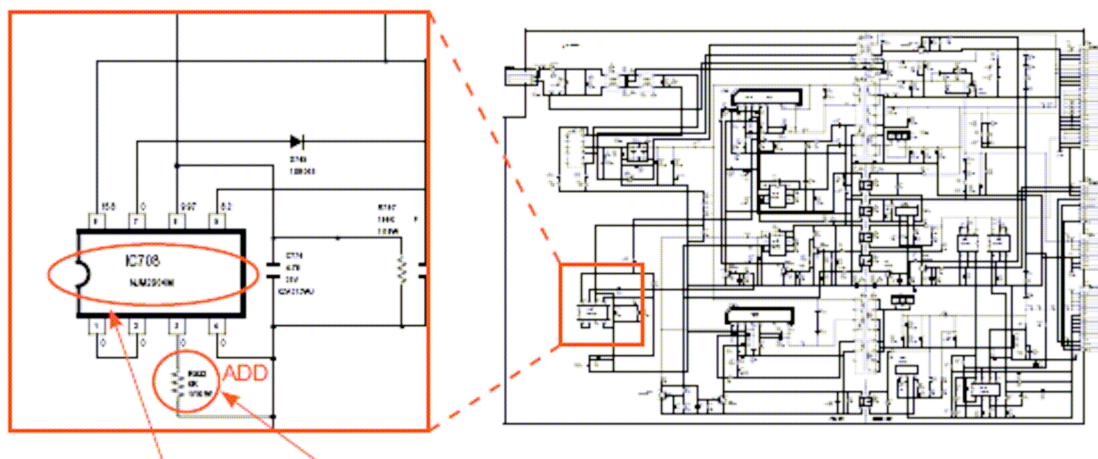
CAUSE IC708.

Figure1: IC708 and R832 location. Power supply schematic diagram location.

ACTION When replacing IC708 fit a zero resistor between pins 3 and 4 as shown in the added diagram figure1 and its location shown in figure 2.

<u>REF NO</u>	<u>DESCRIPTION</u>	<u>PART NUMBER</u>	<u>PRICE CODE</u>
IC708	NJM2904M	VHINJM2904M-1Y	AE
R832	0 Ohm 5% 1/10w SMD	VRS-TV1JD000JY	AA
